# OPÉRATION SANTÉ DU LAC MEMPHRÉMAGOG (PHASE 1)

**SUMMARY OF THE REPPORT  
APRIL 2005**

SUMMARY OF THE FINAL REPORT

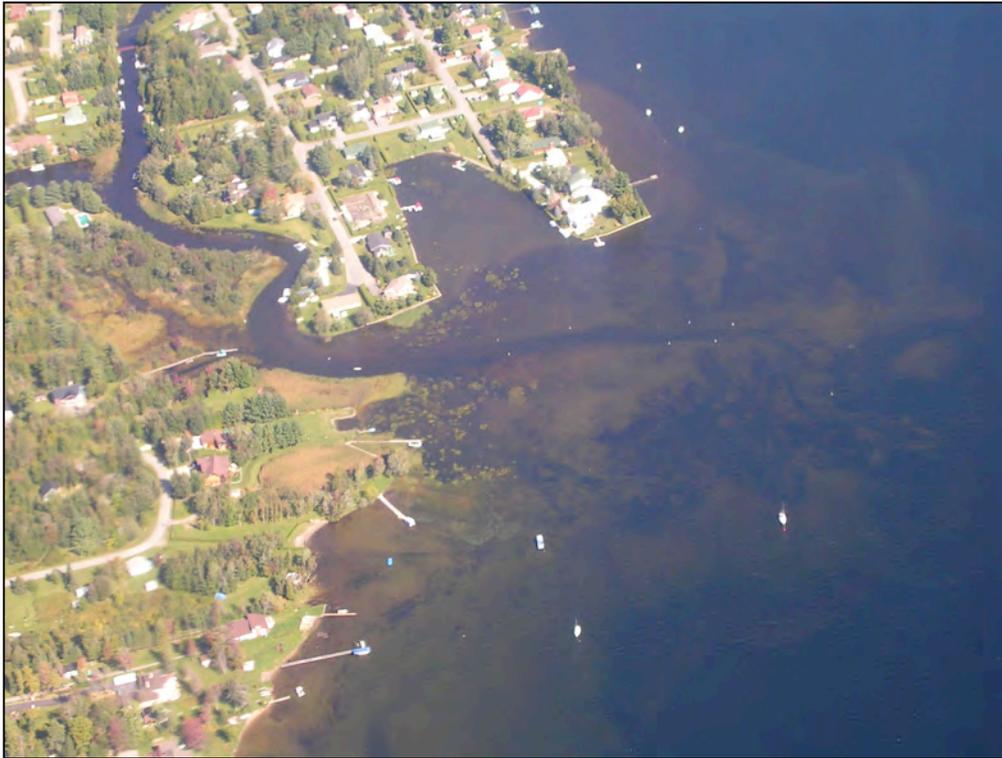
**Figure 2: Amounts of sediments coming from upstream erosion in Castle Brook and from the artificialized area of Southière-sur-le-lac**

Note on Figure 2 the brown cloud caused by fine particles coming in through Castle Brook and the highly artificialized shoreline of Southière-sur-le-lac.

The Southière-sur-le-lac area is one of the sectors which manifest the most symptoms of “premature ageing”, and its state of health appears as worrying. This is why we recommend that this area be prioritized in a plan of action which aims at reducing the number of degradation sources affecting Lake Memphremagog. Action in this area should mainly consist in restoring the Southière-sur-le-lac shoreline as well as reducing the input of sediments and nutrients (see chapter 10). To this effect, special attention should be paid to road ditches and to the upper part of Castle Brook.

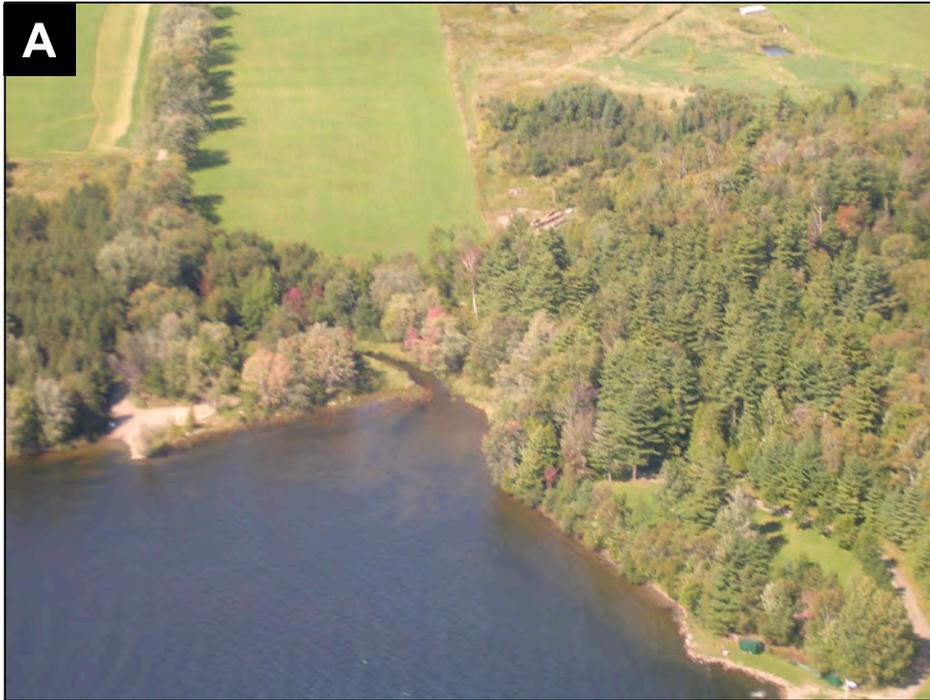
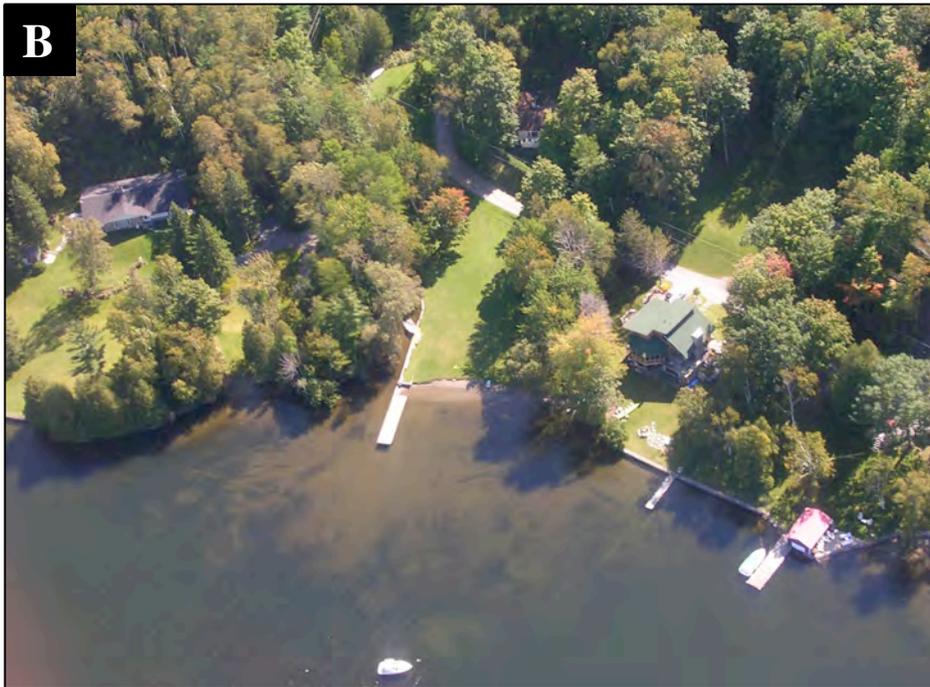
**Figure 3: Inputs of sediments coming from upstream erosion in McIntosh Brook and from the brook in Cummins Bay.**

- Channel Bay (1094 Brook and Benoit Brook – also called McIntosh)
- Cummins Bay (brook)
- The bay located between these two bays.

In conclusion, the area of Channel and Cummins bays manifests symptoms of “premature ageing”, therefore of degradation, mainly at the three meter mark (density of the water plant community, abundance of algae and sub aquatic deltas). In order to slow down this process, the main actions in this area should consist in restoring the shoreline as well as reducing the input of sediments and nutrients (see chapter 10). Ditches and the three brooks should also receive special attention. It is also important to us to characterize the waters of 1094 Brook as well as those of the brook which flows into Cummins Bay.

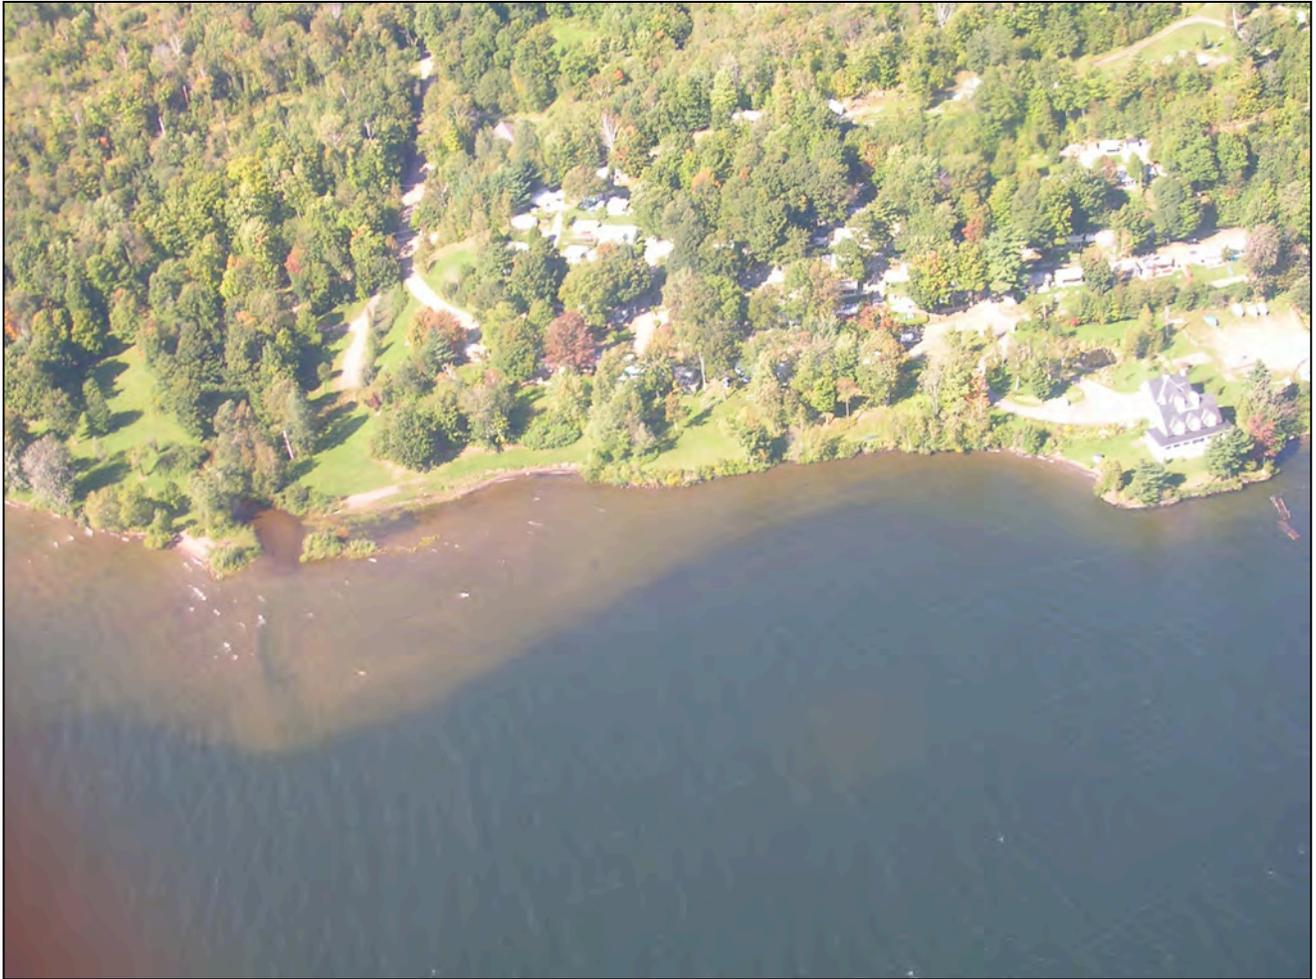
**Figure 5 : Sediment inputs coming from erosion upstream of Château Brook**

- Surroundings of the Vale Perkins' wharf and Vale Brook
- Surroundings of Château Brook and the landing ramp

Vale Perkins shows as one of the least damaged areas since, in general, it shows few symptoms of “premature ageing”. Also, the environmental conditions in place do not favor siltation or the multiplying of aquatic plants. However, the abundance of aquatic plants and siltation in certain spots reveal ongoing deterioration. Furthermore, the abundance of diatoms algae and green algae indicate that the water is rich in nutrients. In order to limit this ageing and to preserve the quality of water in this sector, it would be proper to set in motion certain initiatives aimed at reducing the input in nutrients and sediments (see chapter 10). Also, special attention should be devoted to the ditches, the shoreline, Château and Vale Brook, as well as the boat launching ramp and the public wharf.

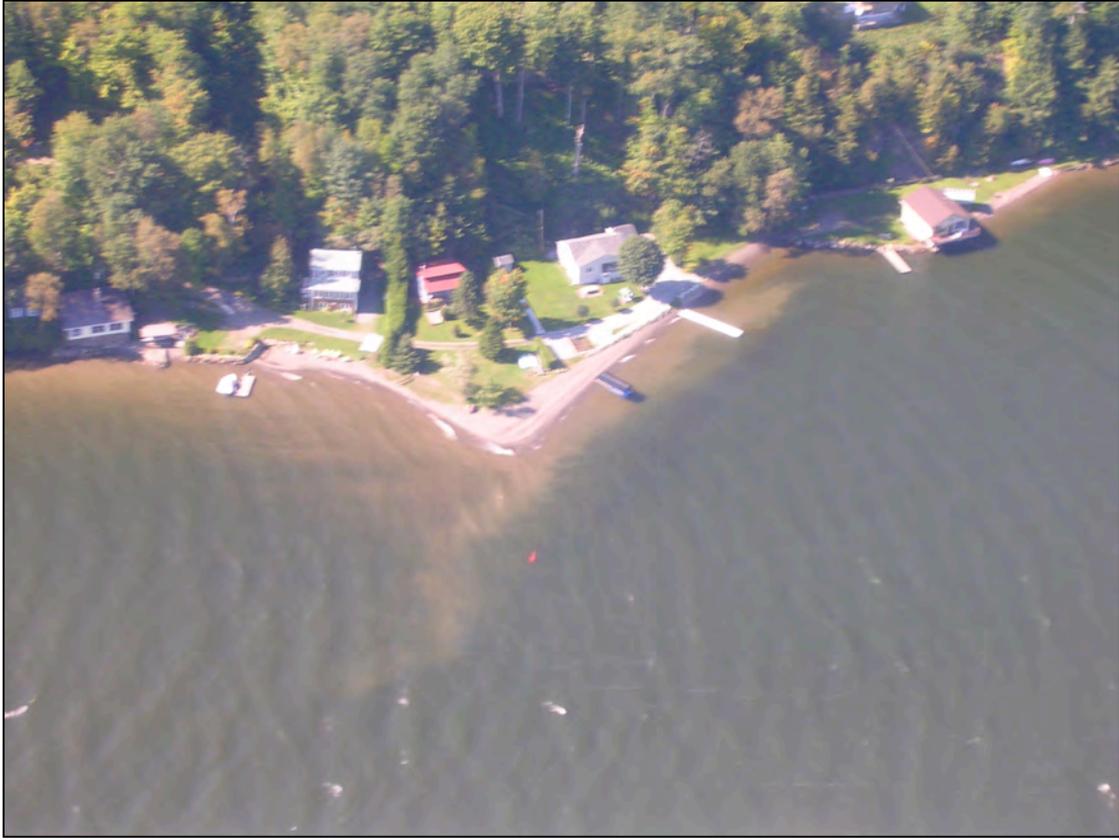
**Figure 6 : Abundance of sediments on the Leadville area littoral (near Round Island)**

- The portion near the boarder (surroundings of Bear Brook)
- The bay located to the West of Skinner Island

In conclusion, Leadville is an area that indicates few symptoms of “premature ageing”, therefore of degradation. However, the formation of an organic layer on the rocks, the presence of diatoms algae and green algae, as well as the abundance of aquatic plants in certain areas all indicate that the sector is currently deteriorating. As a preventive recourse, we call upon you to instigate different actions aimed at reducing the input in nutrients and sediments (see chapter 10). In particular, the ditches and brooks in this area should receive special attention. It would also be pertinent to characterize the quality of water in these brooks.

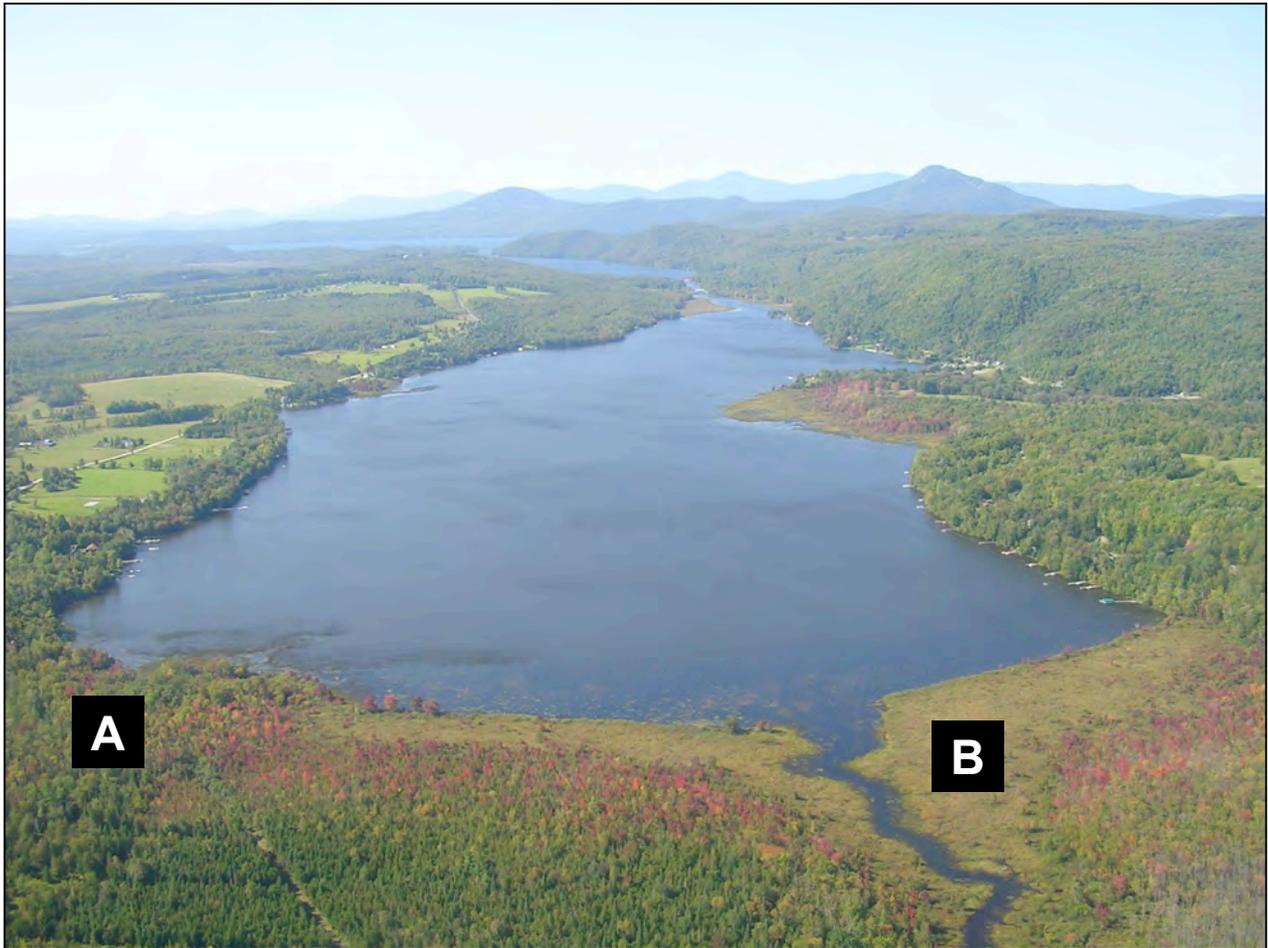
**Figure 7 : Abundance of sediments and aquatic plants  
at the mouth of Gale Brook (A) and Bunker (B)**

- Bunker Brook
- Gale Brook
- McCutcheon Brook
- Fitch Brook

In conclusion, the Fitch Bay area (North East) is the sector that shows the most severe symptoms of “premature ageing”, as attested by the sedimentation, the invasion by aquatic plants, the proliferation of green algae and the poor quality of its waters. This sector will have to be addressed as a priority in the future plan of action aimed at reducing the sources of degradation of Lake Memphremagog. The main actions to be taken should include a reduction in the inputs of nutrients and sediments which travel through the ditches and Bunker, Gale, McCutcheon and Fitch Brook, as well as the restoration of the artificially planned shoreline (see chapter 10).

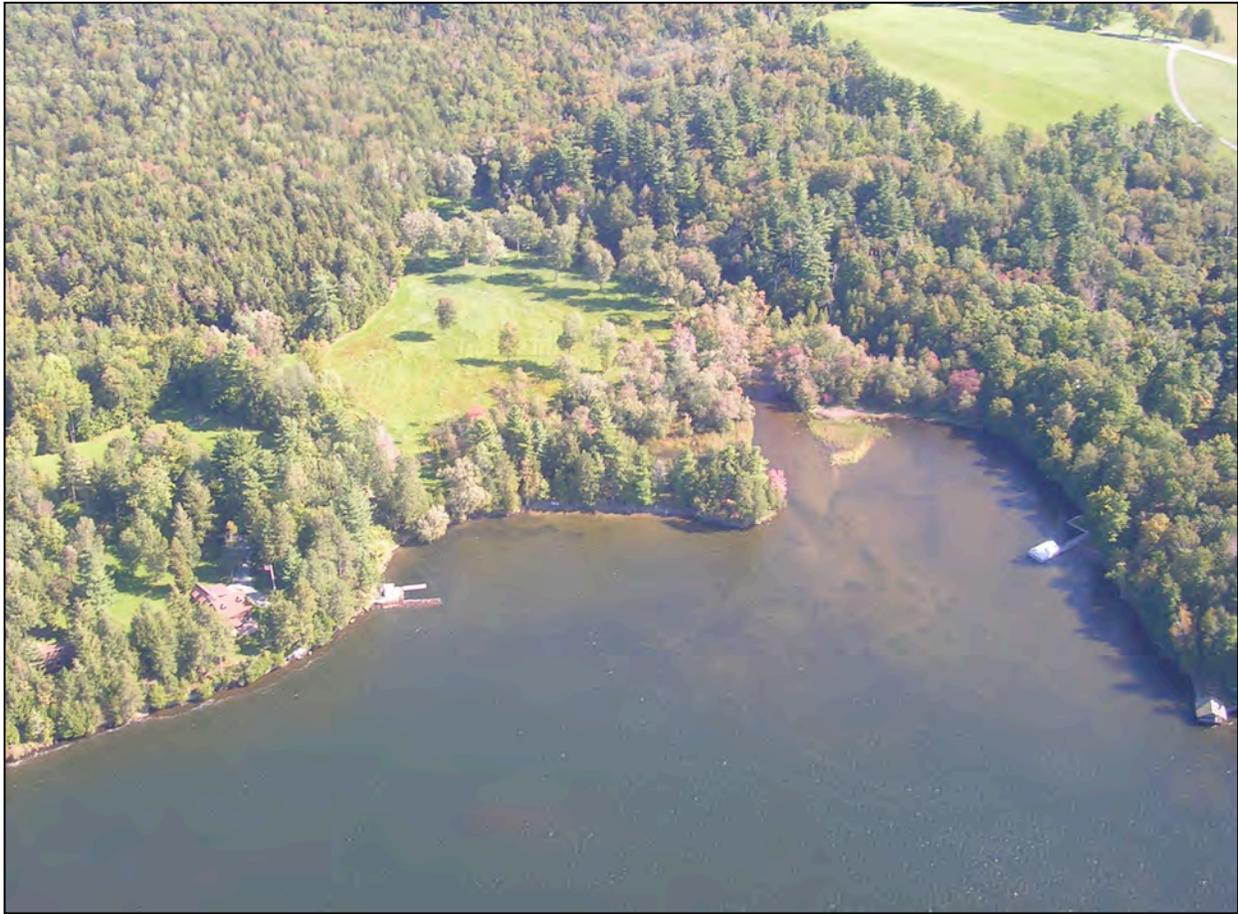
**Figure 8 : Inputs of sediments resulting from erosion upstream of Taylor Brook**

- The end of MacPherson Bay (Taylor Brook and unnamed brook)
- The end of Quinn Bay (Boyton Brook and unnamed brook)
